Transmission Surge – Lurch - Lunge

Sev.#: 2 Det.#: 5 Occ.#: 4 IRN#: 40 GVS-CORE ID: N19-228256

Discovery: Submitted by external investigator due to a NHTSA informal request for “K2XX Transmission jerk/lunge forward and harsh shifting”.

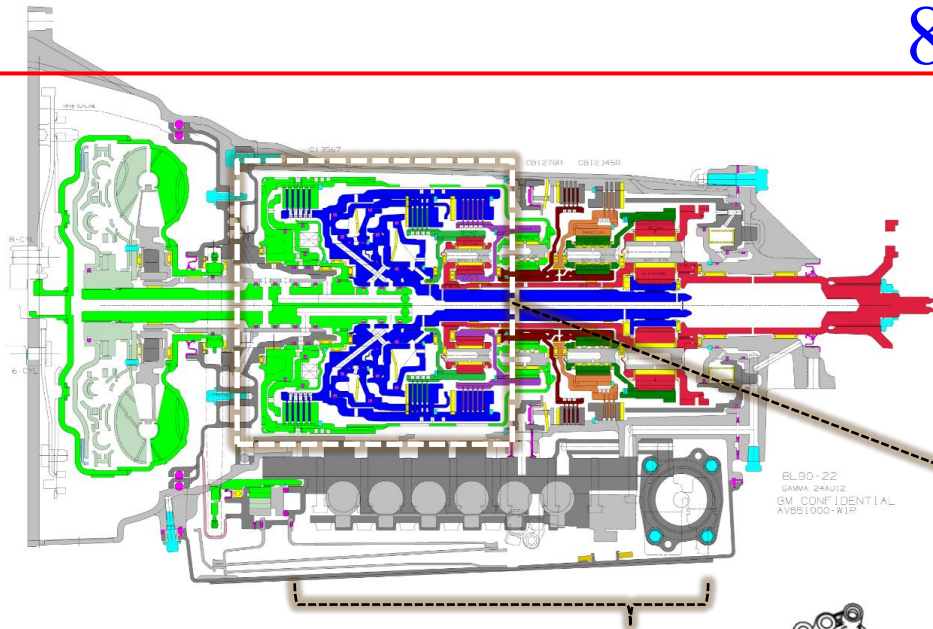
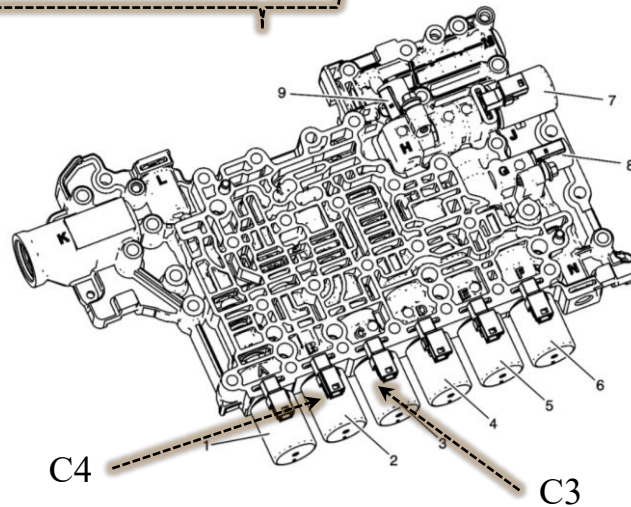
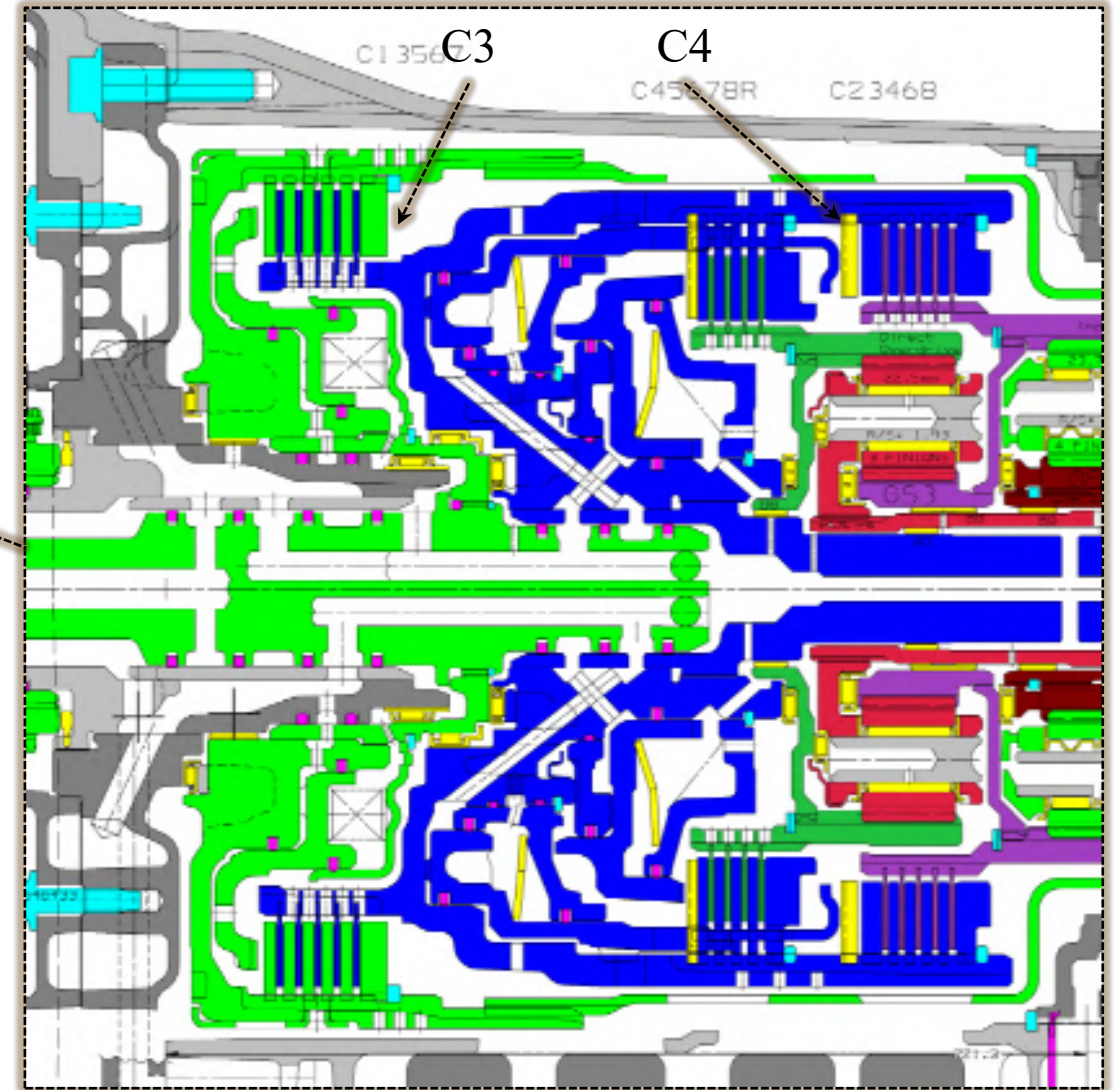
8L90 Cross Section

- In Park and Neutral, C1278R and C12345R are applied
- For the shift into Drive, C3 (C13567) is applied in addition to C1278R and C12345R
- For the shift into Reverse, C45678R is applied in addition to C1278R and C12345R
- For a 1-2 shift, C4 (C23468) is applied and C3 (C13567) comes off while C1278R and C12345R remain applied.

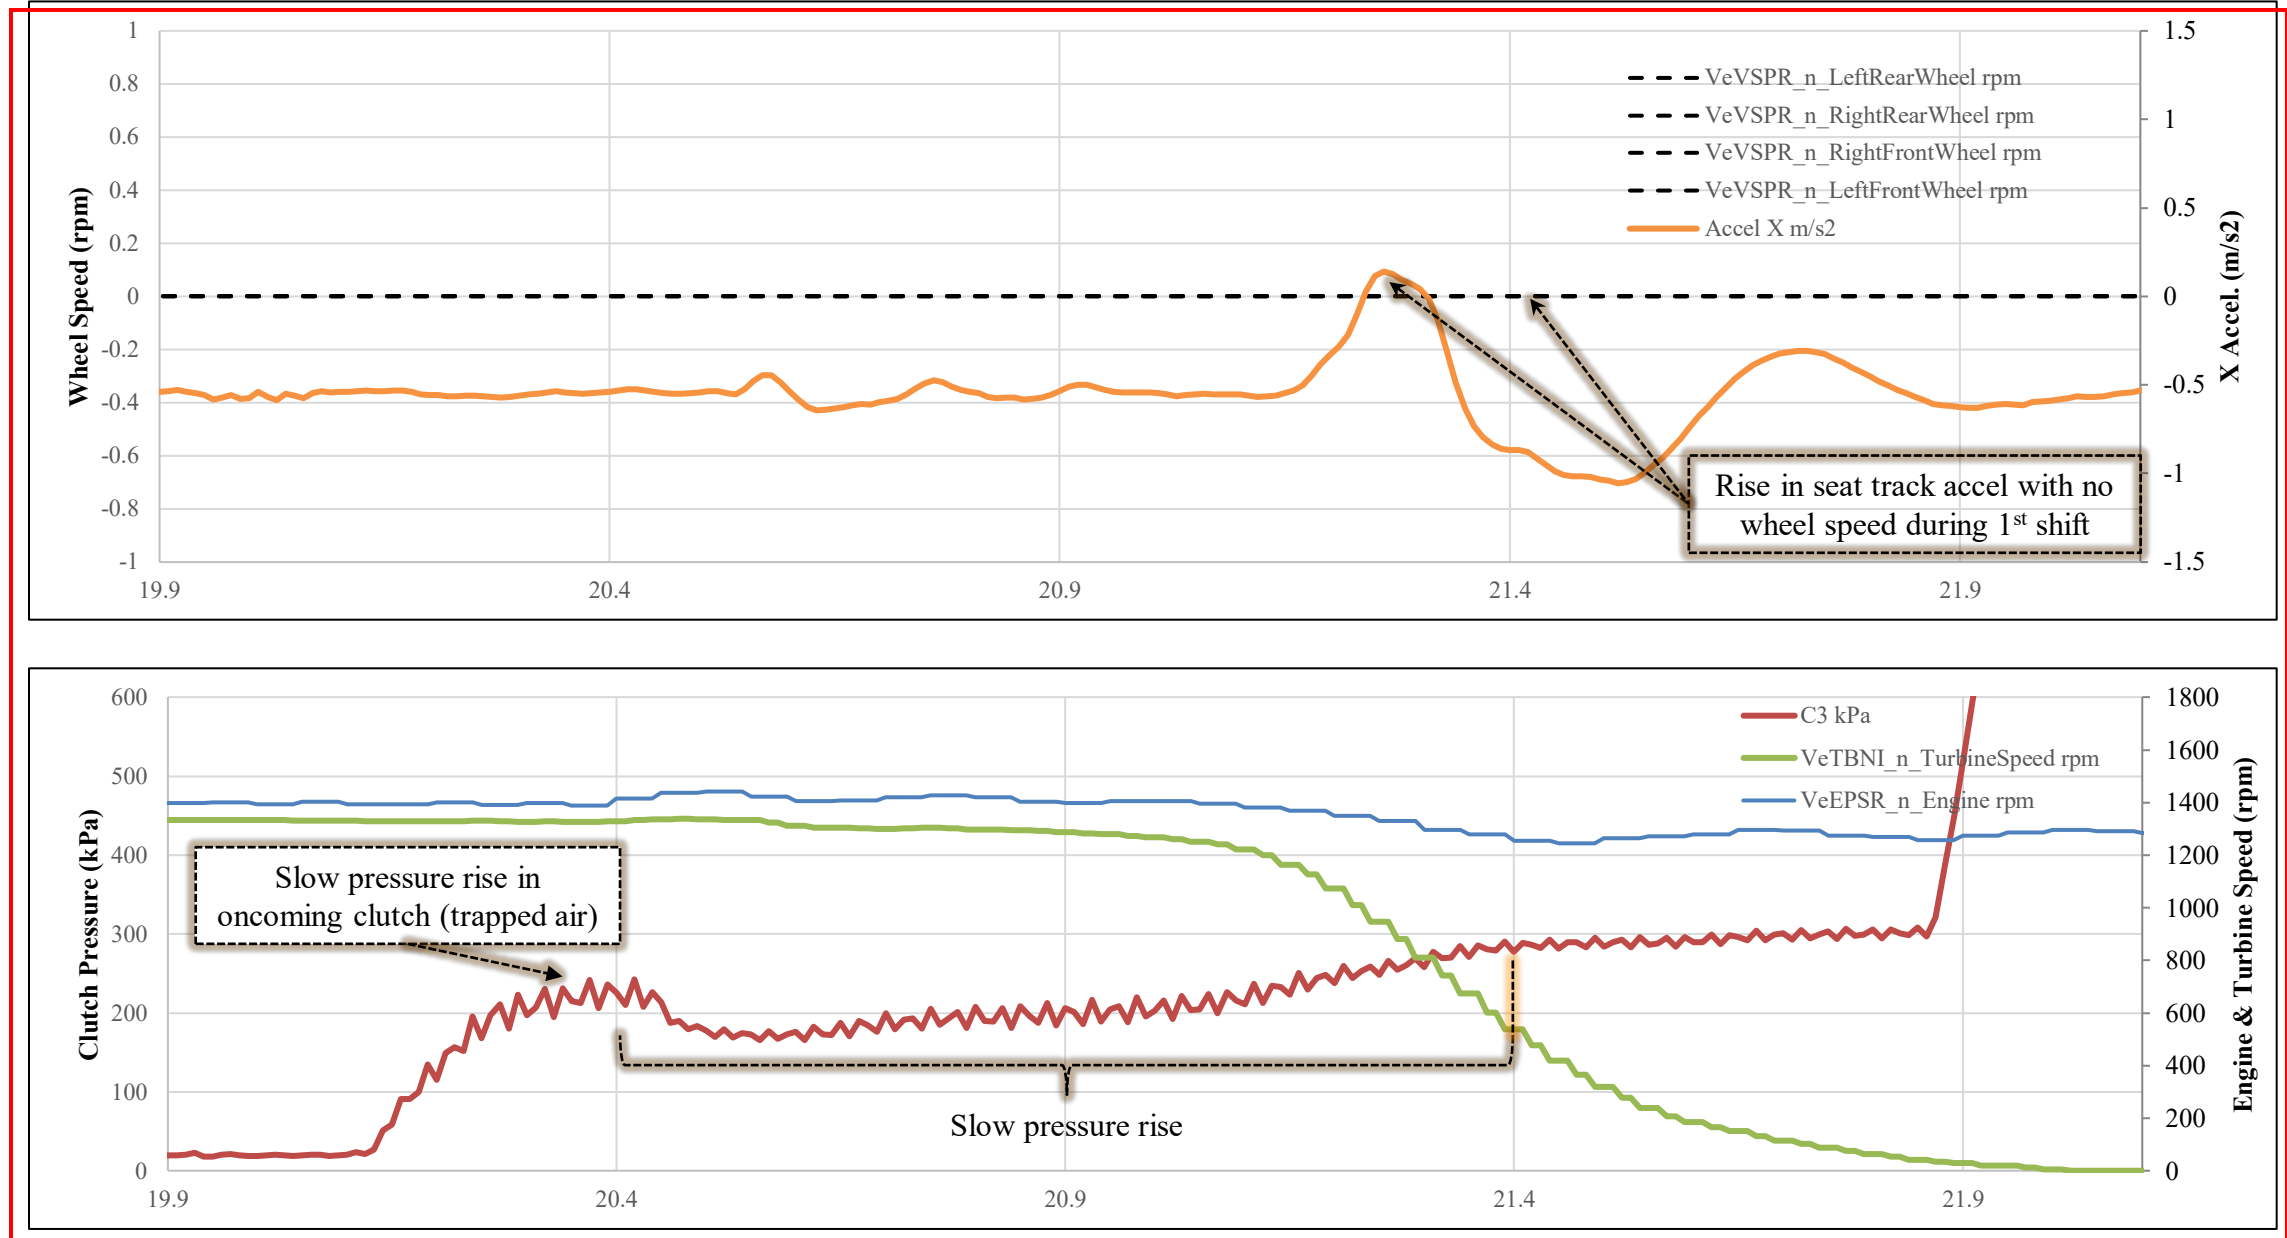
Effect of Condition (*Abnormal* 1st Shift to Drive; ~18% Brake Apply)

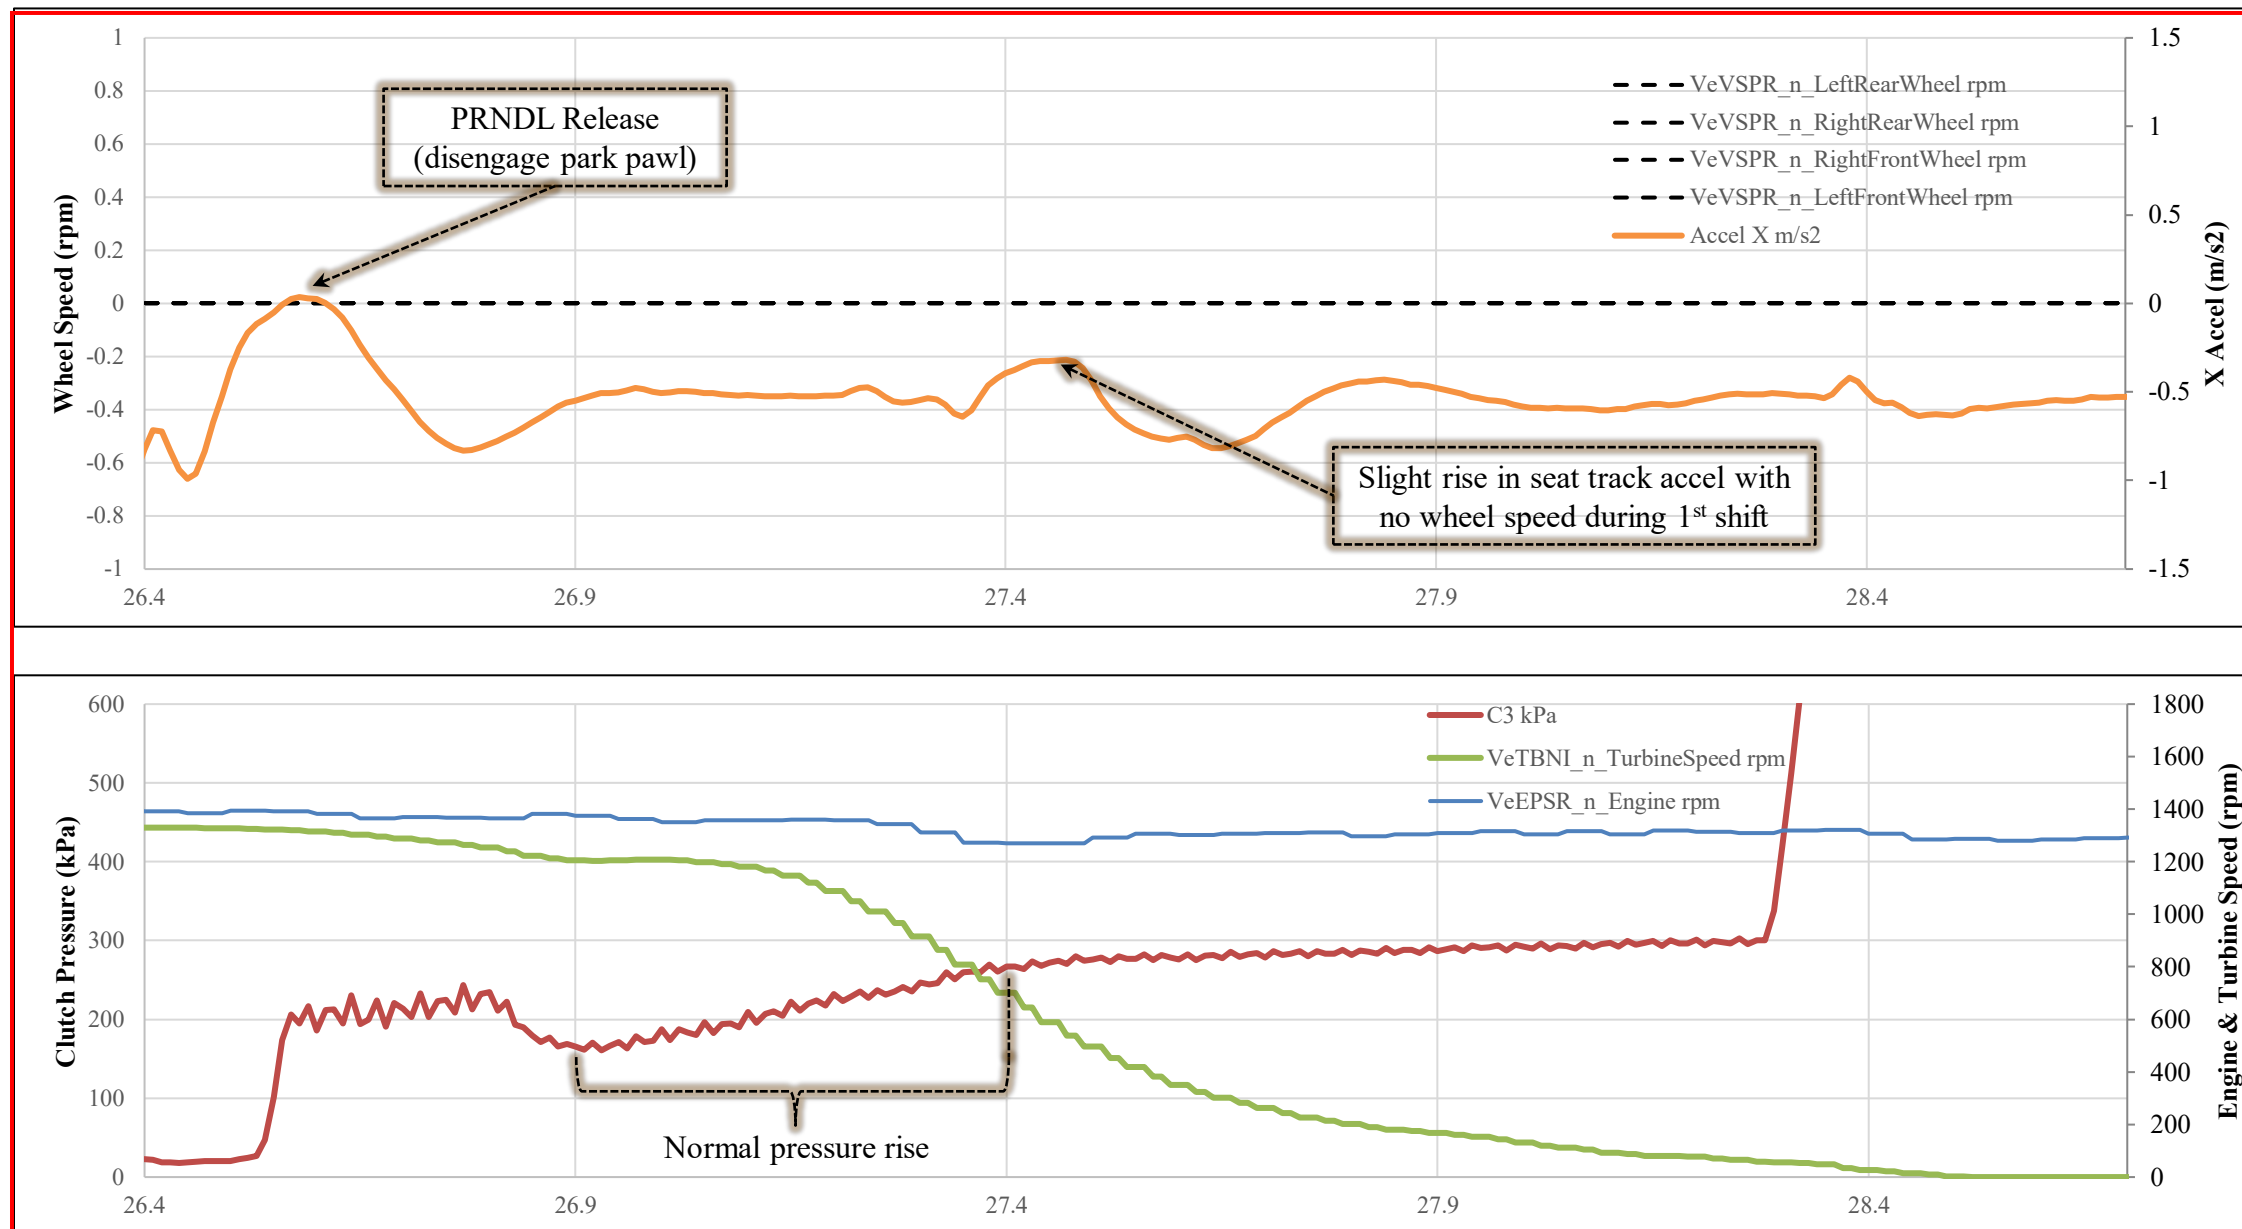
Effect of Condition (*Normal* 1st Shift to Drive; ~18% Brake Apply)

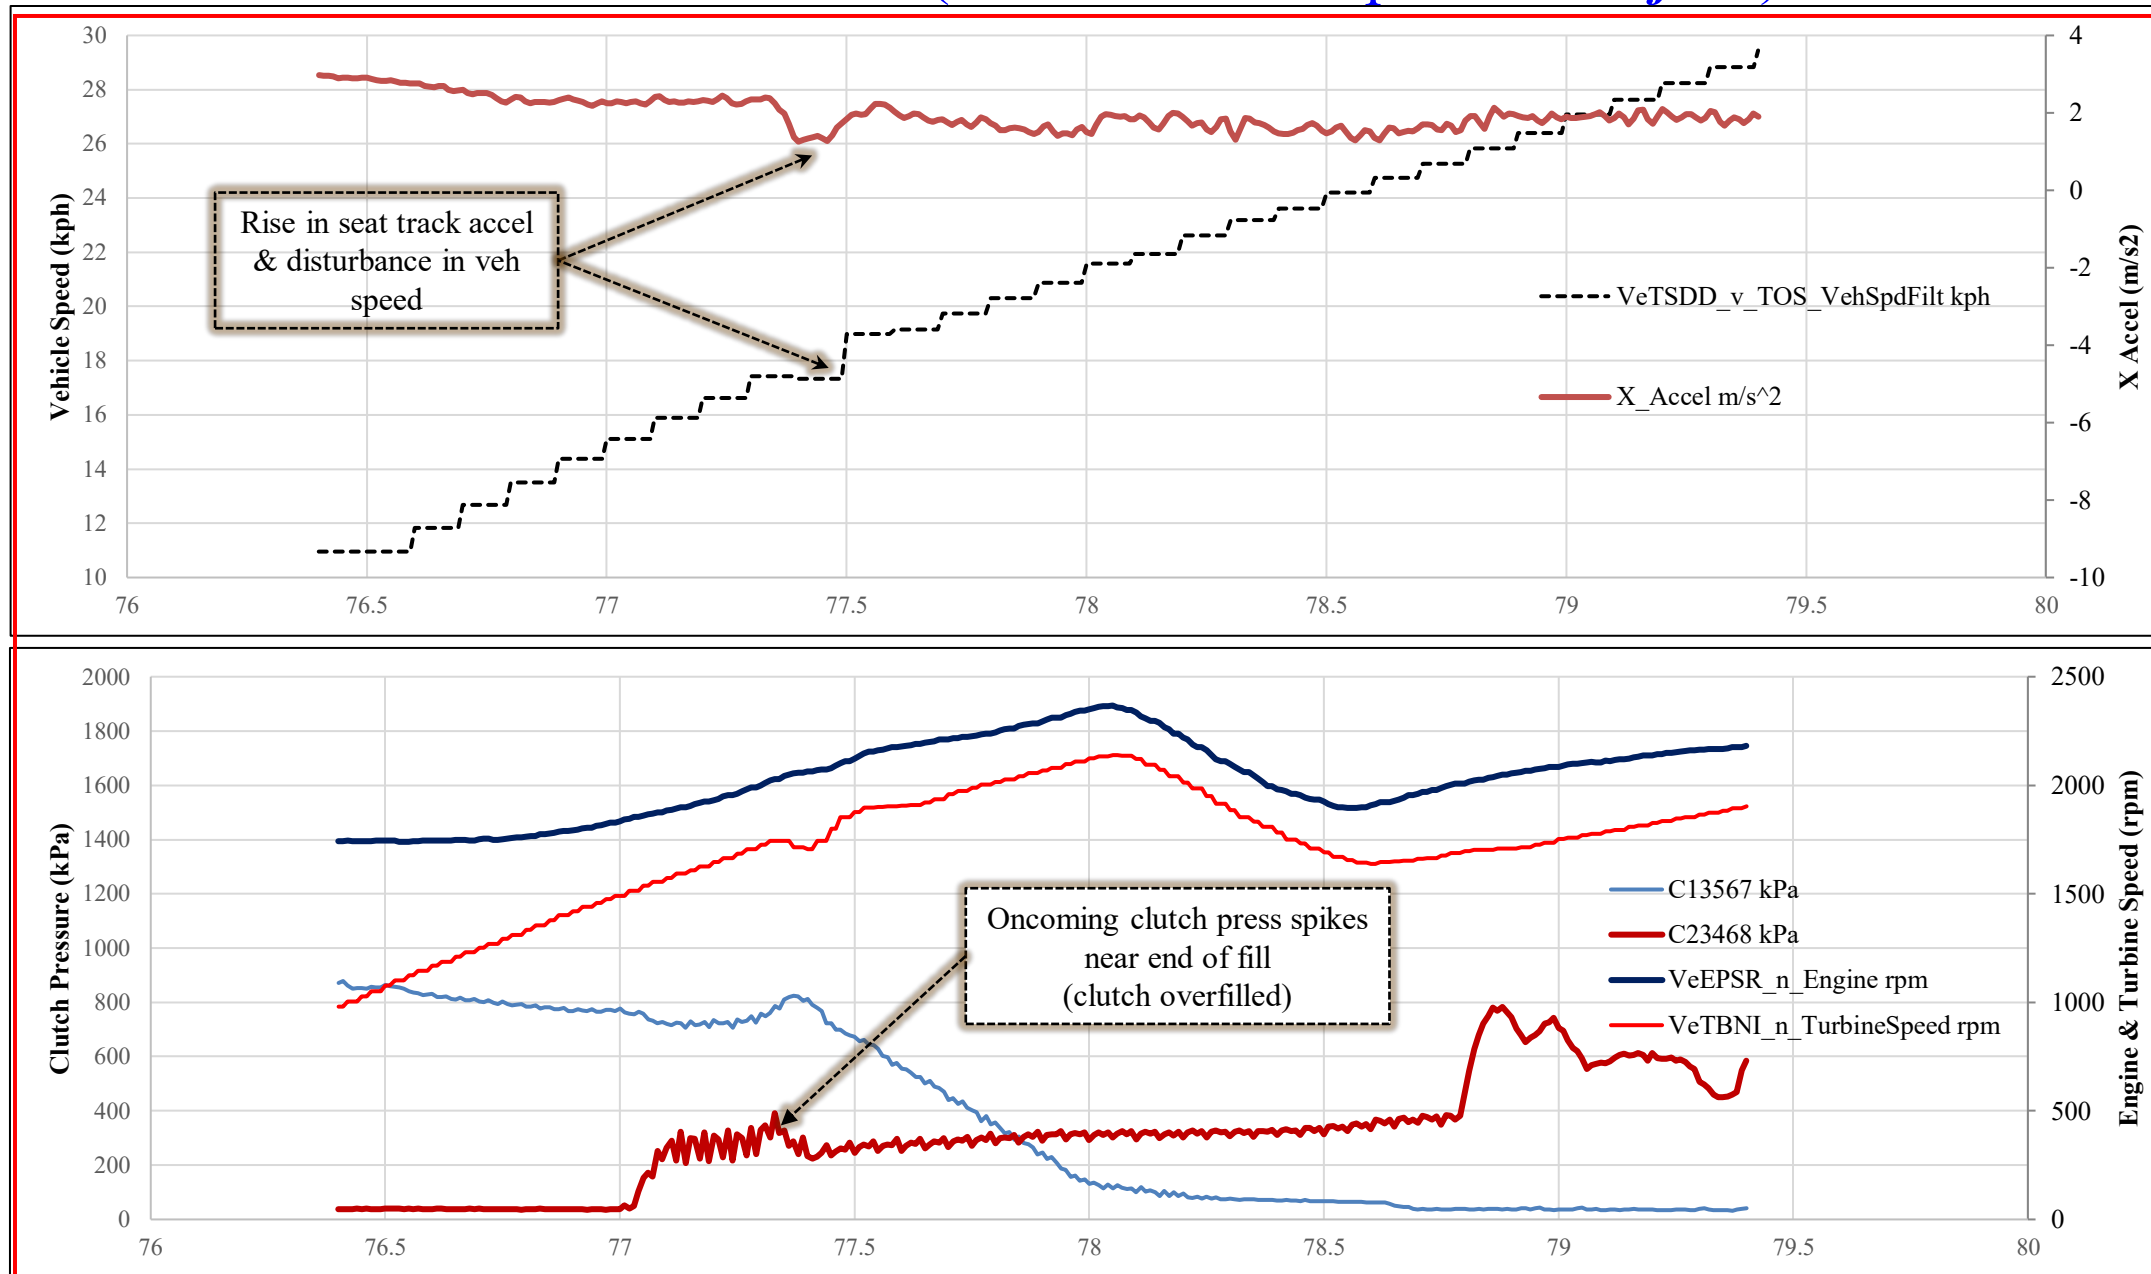
Effect of Condition (*Abnormal* 1-2 upshift *with jerk*)

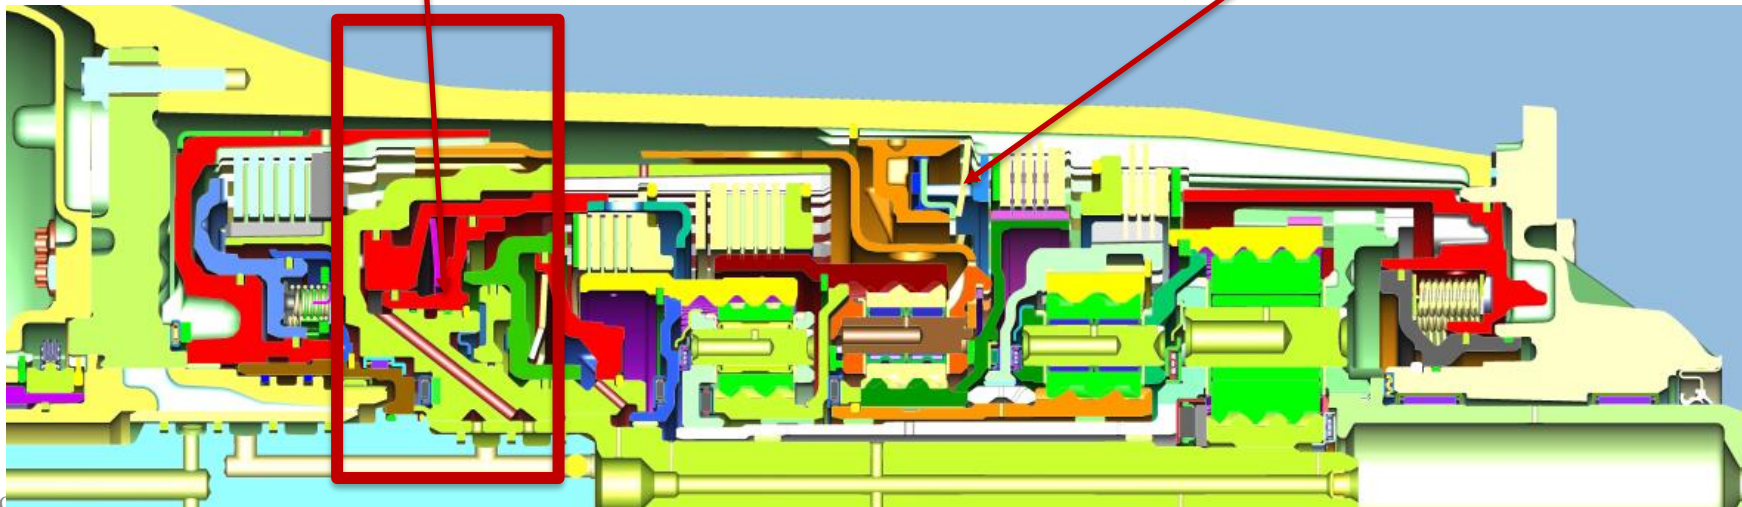
8 Speed: Root cause - Non linear load curve for C1 and C4 return springs clutches

Current 3-1 coast-down and 1-2 shift variation can be perceptible to the customer.

8L90- C4 updating spring thickness and curve.

8L90- C1 updating spring thickness and curve.

Change to a different geometry for **C1 return spring** will result in a higher load for any given deflection, a faster release of the C1 clutch, and improved shift quality.

- Thickness will increase from 1.91 mm to 2.03 mm,
- Free height will increase from (7.05) mm to (8.64) mm,
- Slot height will decrease from (4.6(mm to (4.42) mm,
- And slot diameter will increase from 183 to 187.96.

Change to a different geometry for **C4 return spring** will result in a higher load for any given deflection, a faster release of the C4 clutch, and improved shift quality.

- Free height will increase from 5.18 mm to 5.46 mm.
- Slot ID will increase from Ø133.35 mm to Ø138.43mm
- Thickness increases from 1.72 to 1.91 mm..

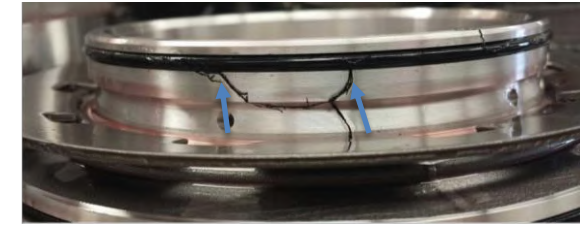
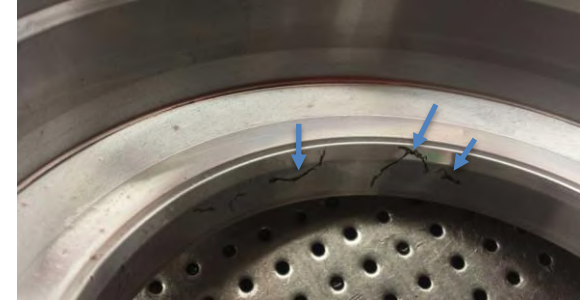
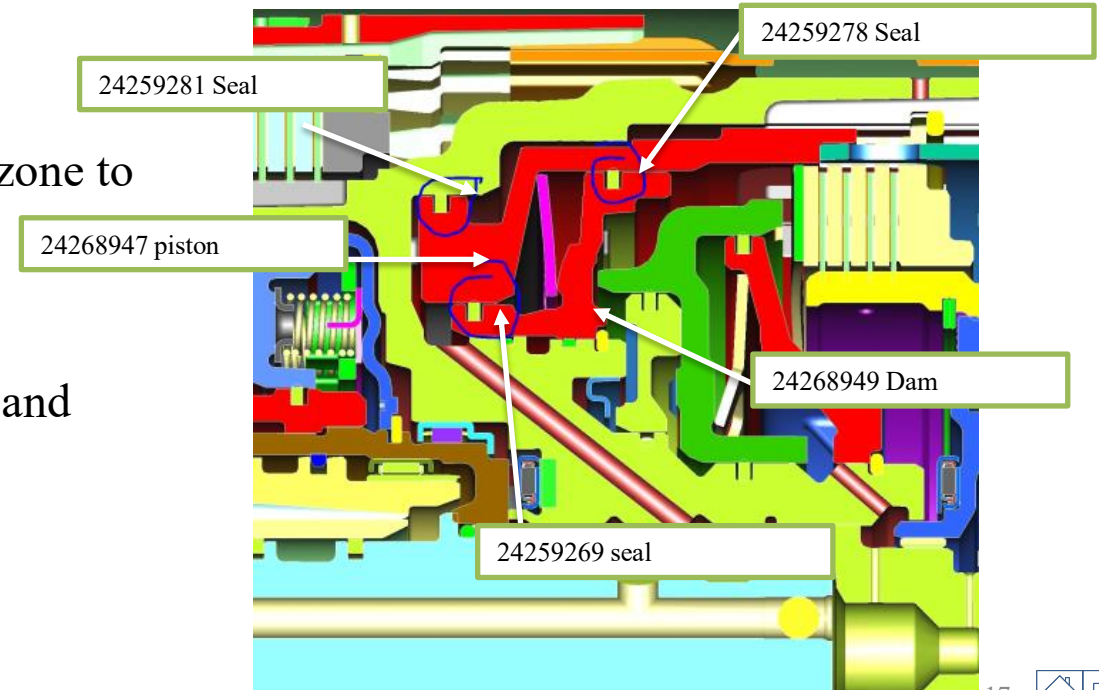
8 Speed: Root Cause - High seals compression

Seal wear was noted in the small diameter seal of C2 dam and C4 dam.

Is causing an increase in drag which affects the clutch apply and exhaust times.

Decreasing compression to 2% MIN on D-rings by reducing:

1. O.D of the D-ring,
2. Adjusting the cross-section dimensions of D-ring to reduce rolling tendency
3. Refining the surface finish spec. of piston's seal functional zone to obtain a 0.8Max Ra.

These changes will help in lowering drag and hence clutch exhaust and apply times as well as low mileage seal wear.

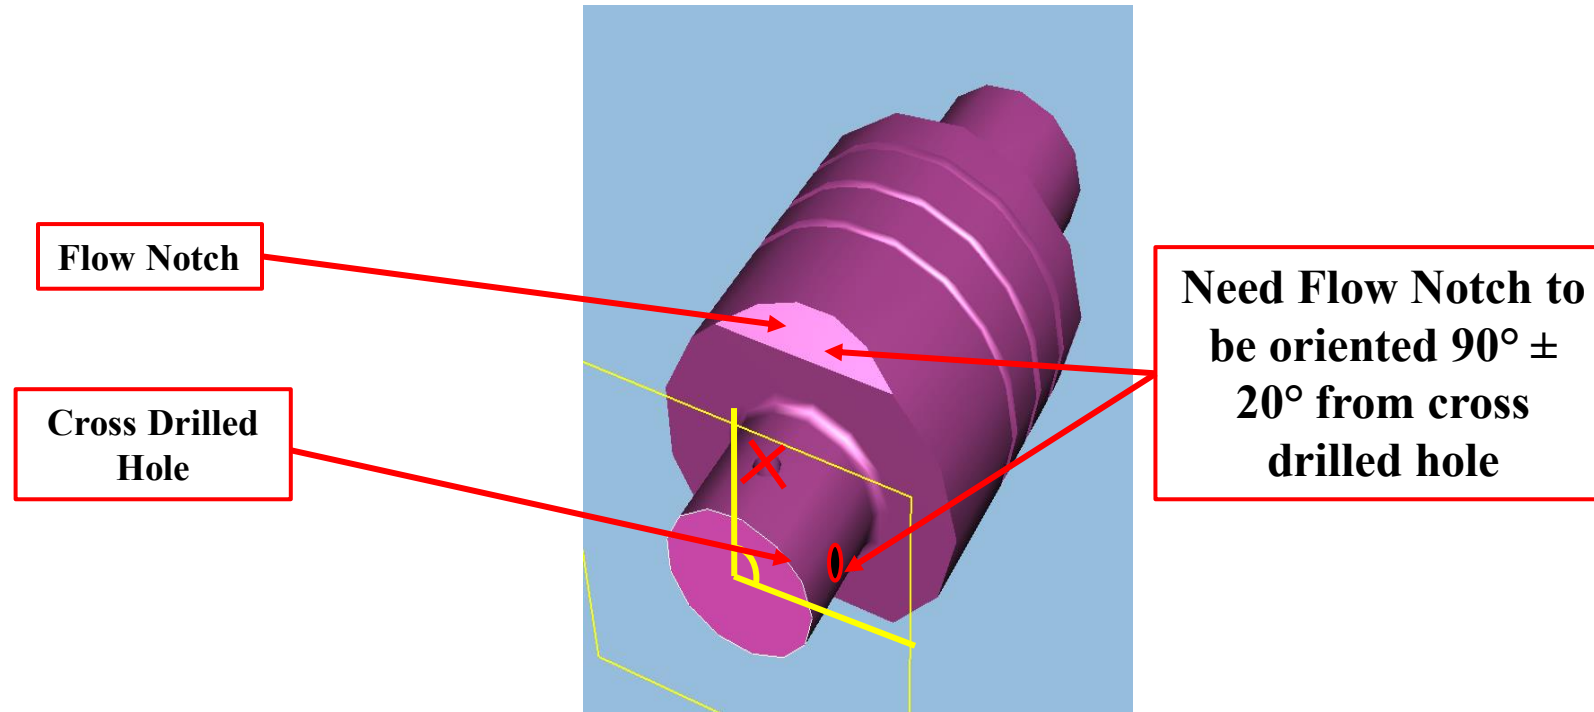
8 Speed: Root Cause - C4 Valve pressure orientation

- Valve design causes inconsistent clutch fill times leading to poor shift quality
- Problem occurs when orientation of cross drilled hole lines up with flow notches.
- Change orientation of cross drilled hole in valve so the axis is ± 20 degrees parallel to the flow notch edge
