**IN THE UNITED STATES DISTRICT COURT
FOR THE EASTERN DISTRICT OF MICHIGAN
SOUTHERN DIVISION**

Civil Action No. 2:19-cv-11044

Report of William Mark McVea

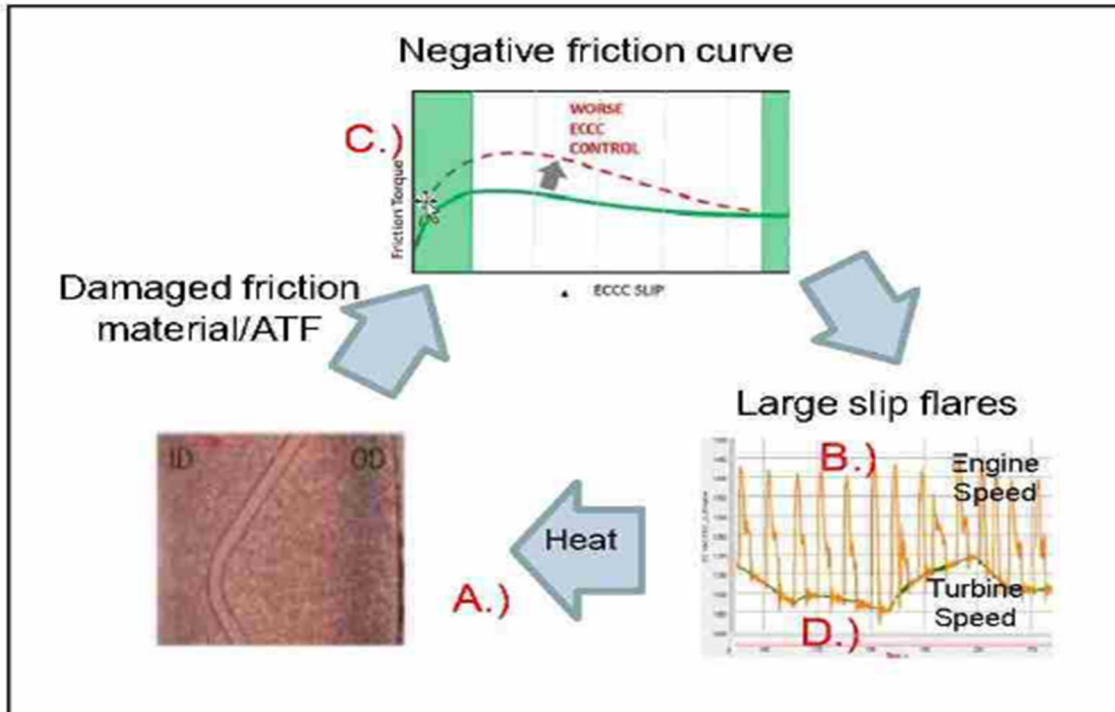
TCC Lifecycle

PX570 at 15 and 16. Radecki Dep. at 192:20-193:24 (discussing the life cycle becoming a “death spiral.”). In this picture, “C.)” is a representation of a marginal friction curve in solid green and an unacceptable curve shown as a dotted black line. In context with the technical description of the interaction of the friction material and ATF as degraded by water in the mix during shift events, the surface of the friction material is changed / worn to the condition shown in “A.)”. The surface condition and the material properties shown in “A.)” is what causes both

“B.)” and “D.)” as explained by Radecki. To add to the discussion, note the frequency response most noticeable in “B.)”. This is a visual representation of stiction in action, and for this clutch design (friction system) the frequency is in the range of 10 to 35 (Hz). In most of the frequency plots recorded by the PICO system, there are prominent frequencies in this range. This statement applies to both the data I recorded and the of the data I reviewed as provided by GM. A more complete summary of the data I recorded, and my review of the data GM presented will be provided in Section IV.D and Appendix 1.

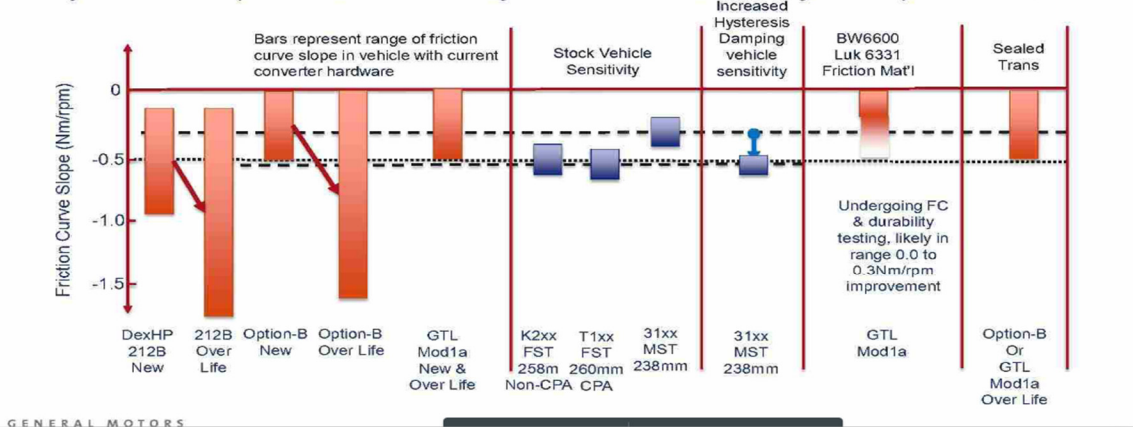
In-vehicle measured friction curves.

31. The 8L family of transmission systems, which began with 212B/WFP6300, was already degrading to a negative slope even before water or time degraded it. Option B had a better curve at its start, but over its life degraded. Not until GM switched to a Mod1a did it pair an ATF with the friction material that could maintain a positive friction curve. PX570 at 20.

System friction performance must stay above vehicle sensitivity line to prevent shudder

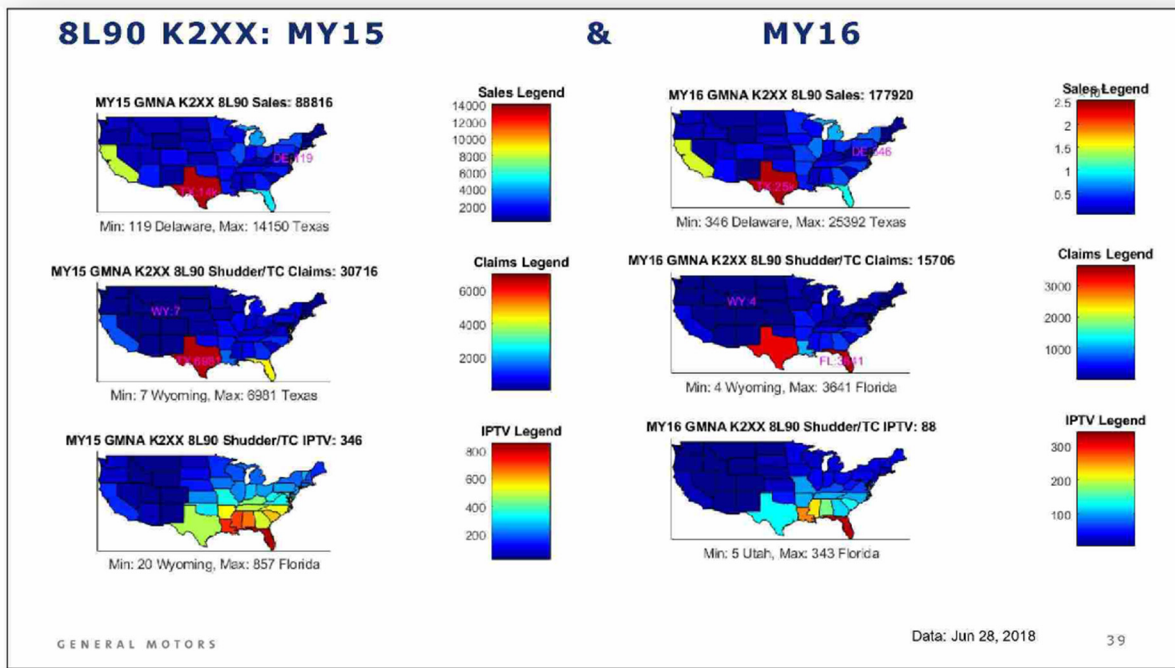
48. Dr. Radecki continued to update his warranty tracking of TCC shudder / torque converter replacements by regions to educate his colleagues. He helped create a “Shudder 101” tutorial for other engineers that showed higher warranty rates for TCC shudder / TC replacement associated with higher dew points and humidity, but also showed generally warranty levels well above GM targets. For example, by January of 2018, the IPTV for the MY15 8L90s was 299 or about 30% claims rate nationally. However, in Florida it was 777, or 77%. PX3 (GM000230201) at 25. By June of 2018, the national rate for MY15 8L90 on the K2XX platform grew to 346 (34.6%) with a Florida level at 85.7%. PX570 (GM000055894) at 39.

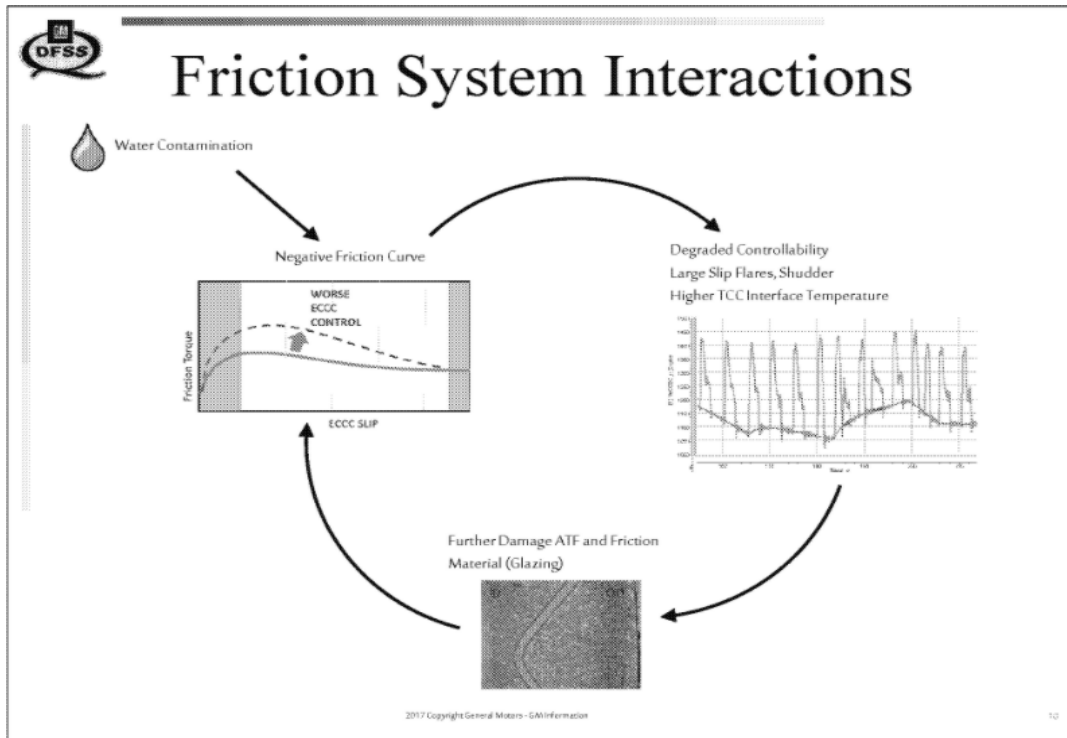
GM000055668 at 10.

66. In a Six Sigma presentation that Dr. Radecki prepared for Bob Gonzales in May of 2017, he also linked the ill effects of water on the ATF to degradation of shift quality, the emergence of shudder, and overall damage to the friction system.

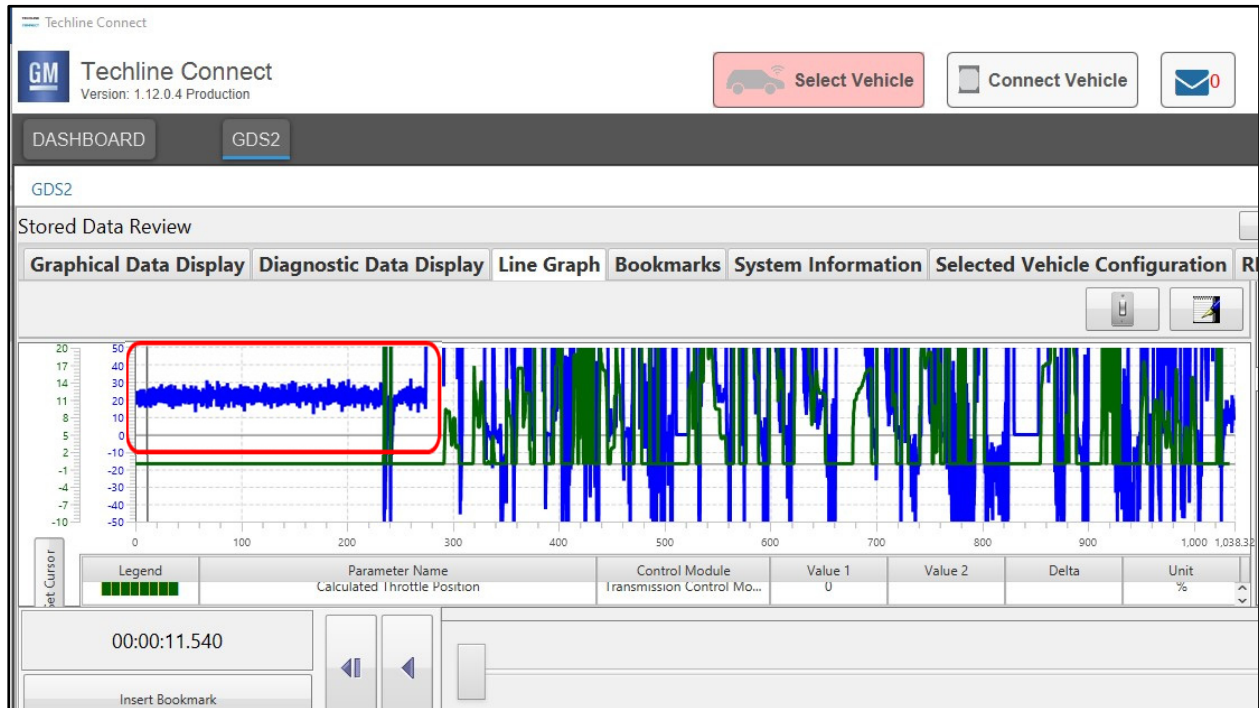
89. My review of some of the results from inspections performed by GM technicians or FSE indicated TCC shudder. As an example, in one data capture the following trace of TCC Slip Speed in green (the difference between the output

rotational speed of the engine / input to the torque converter and the rotational speed of the torque converter turbine / output from the torque converter; this is the slipping speed across the TCC while engaged) as a function of Calculated Throttle Position in blue:

The highlighted section (red box) indicates TCC shudder. This observed phenomenon is evident and similar to data I collected as shown below.
