Transmission Surge – Lurch - Lunge

Sev.#: 2 Det.#: 5 Occ.#: 4 IRN#: 40 GVS-CORE ID: N19-228256

Discovery: Submitted by external investigator due to a NHTSA informal request for “K2XX Transmission jerk/lunge forward and harsh shifting”.

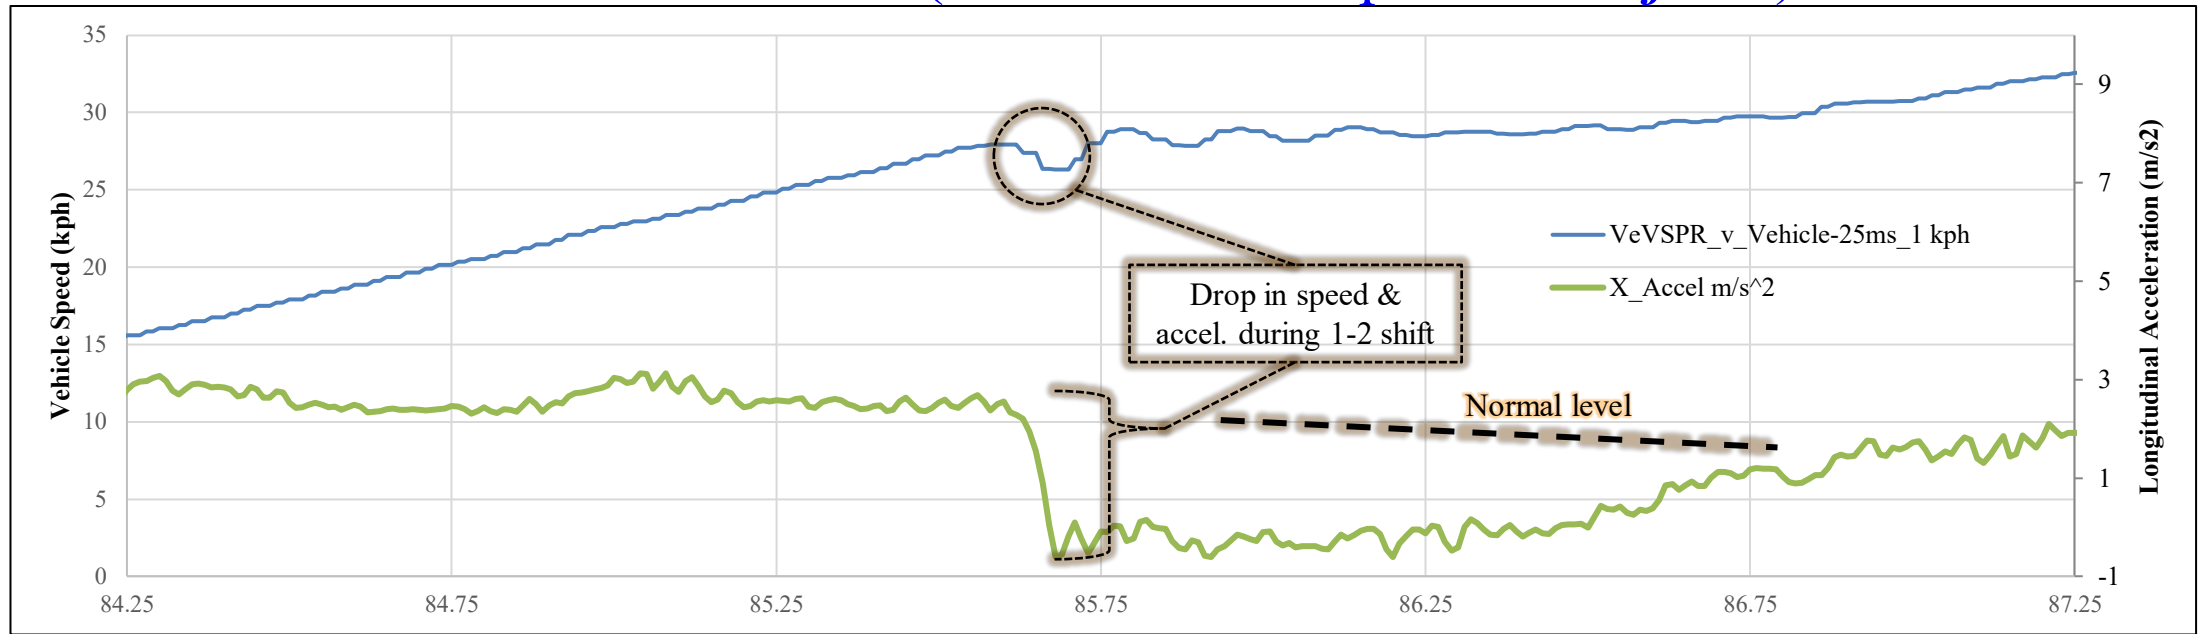
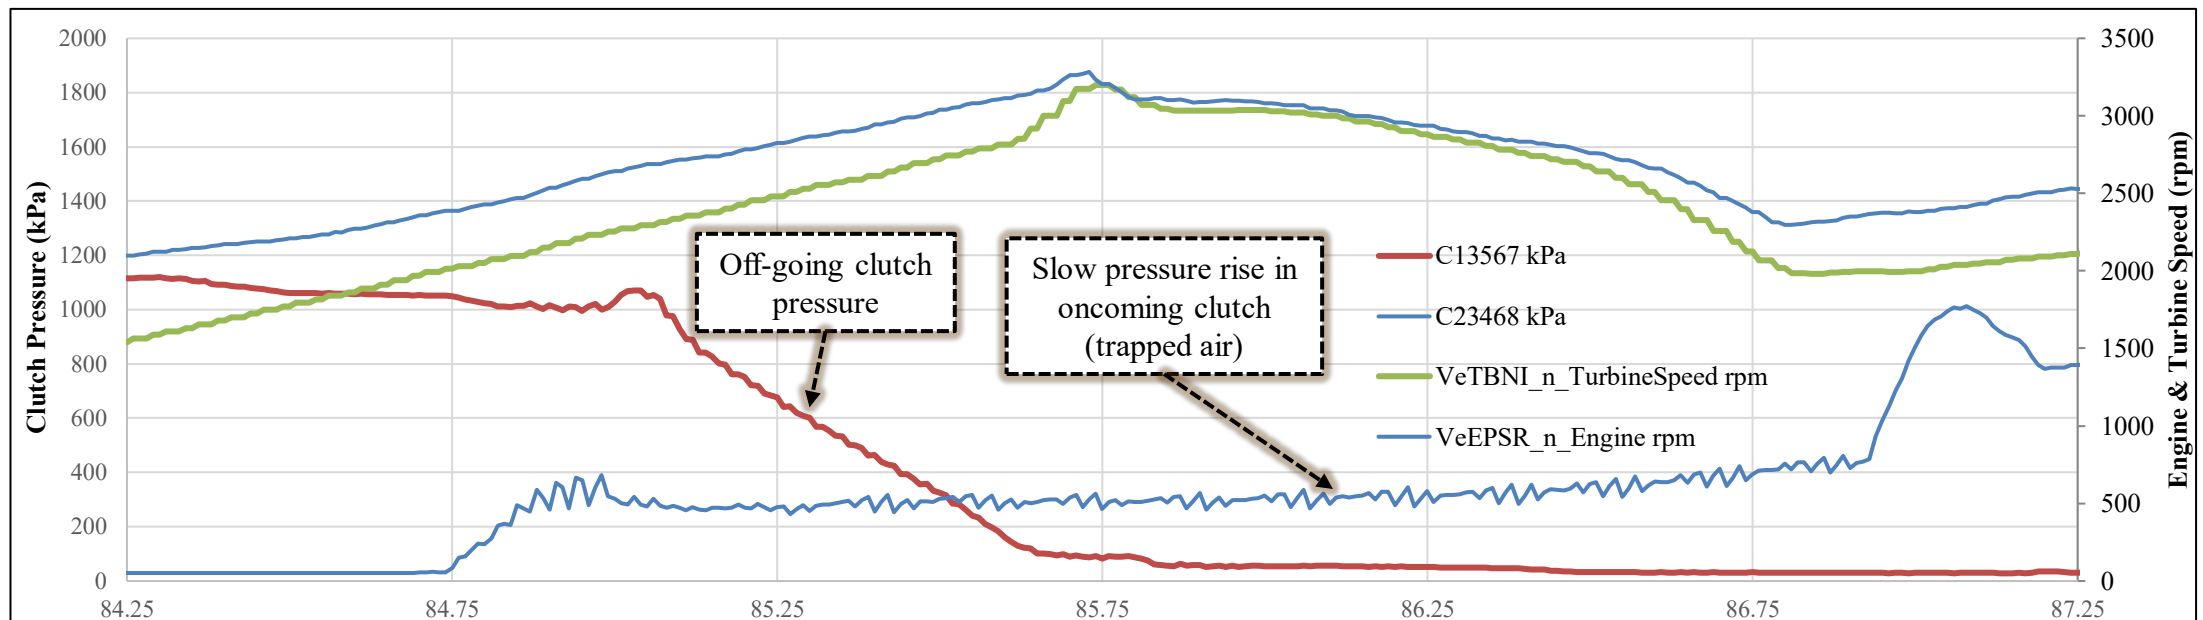
Effect of Condition (*Abnormal* 1st Shift to Drive; ~18% Brake Apply)

- In Park and Neutral, C1278R and C12345R are applied
- For the shift into Drive, C3 (C13567) is applied in addition to C1278R and C12345R
- For the shift into Reverse, C45678R is applied in addition to C1278R and C12345R
- For a 1-2 shift, C4 (C23468) is applied and C3 (C13567) comes off while C1278R and C12345R remain applied.
