**IN THE UNITED STATES DISTRICT COURT
FOR THE EASTERN DISTRICT OF MICHIGAN
SOUTHERN DIVISION**

Civil Action No. 2:19-cv-11044

Report of William Mark McVea

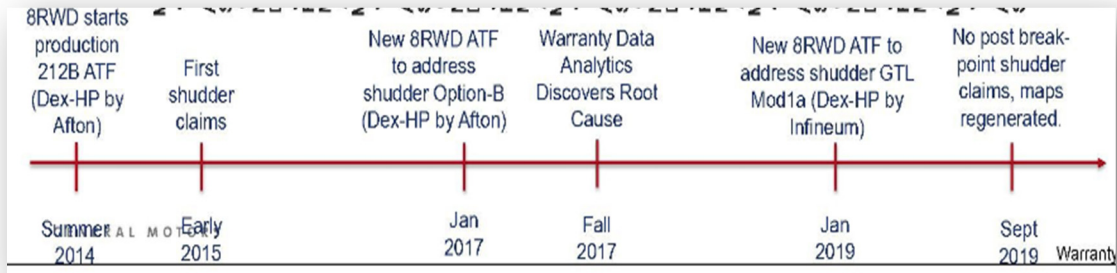
19. GM has used three different automatic transmission fluids for the 8L vehicles. Two were poly-alpha-olefin (PAO) based oils, one patented by GM: 212b. PX1 (GM000284020) at 4. When 212b failed to provide an adequate friction slope, GM replaced it with a modified version in 2017 that it called Option B. Then in 2019, GM introduced a more traditional gas-to-liquid (GTL) fluid it called Mod1a. A timeline in PX576 at 5 shows the following:
